# Property Inspection Report

1003 Holly Ave, Imperial Beach, CA 91932  
Inspection prepared for: Michelle Barajas  
Date of Inspection: 6/2/2020 Time: 2:00 PM  
Age of Home: 1959 Size: 1215 sq ft  
Weather: Clear

## Report Summary

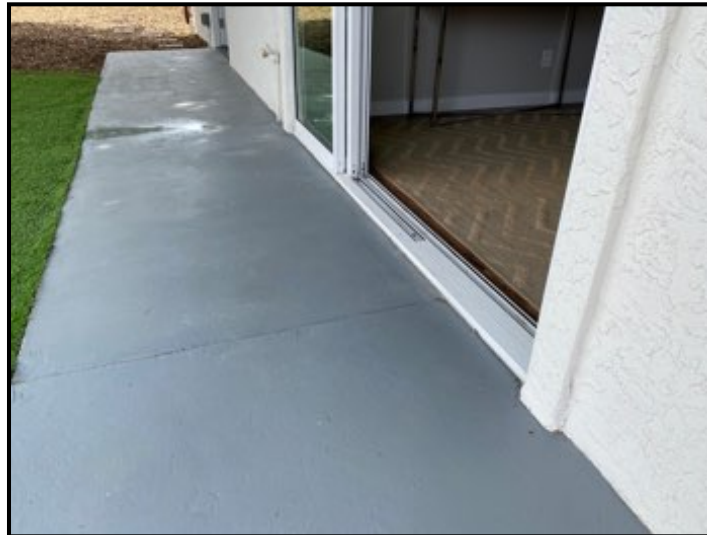
7.1. At points around the residence, there are similar elevations between the exterior grade and the interior floors. Such conditions are obviously not ideal, and moisture intrusion could result. The door thresholds must be kept sealed and the base of the walls monitored, and particularly during prolonged rains.

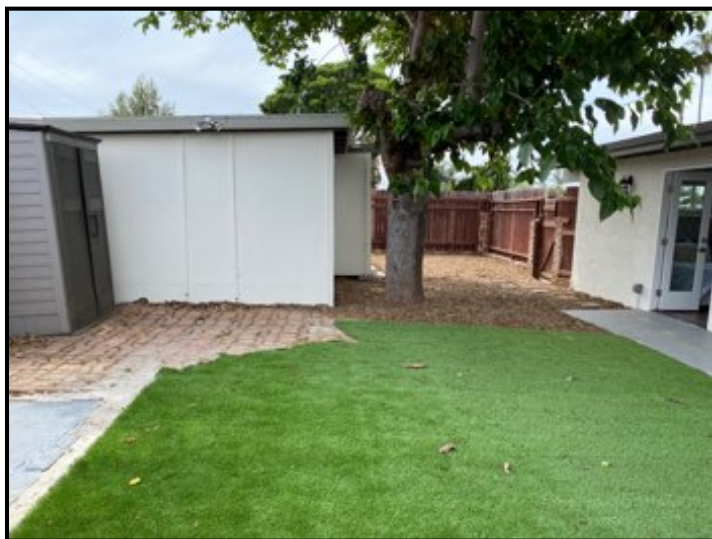
8.1. Tree branches overhanging roof and/or against siding. Trim trees that are in contact or proximity to home, as branches can abrade siding and damage roofing.

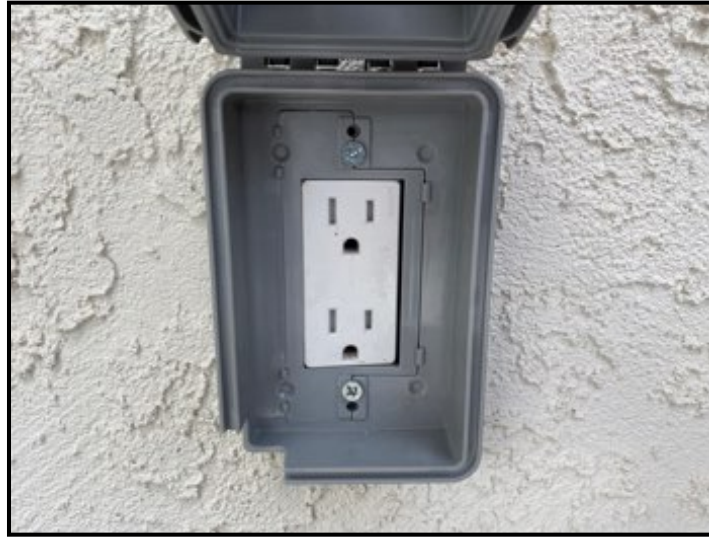
12.1. Exterior outlet did not respond to test during the time of inspection. Unable to determine the exact cause. Recommend correcting advise repair by licensed electrical contractor.

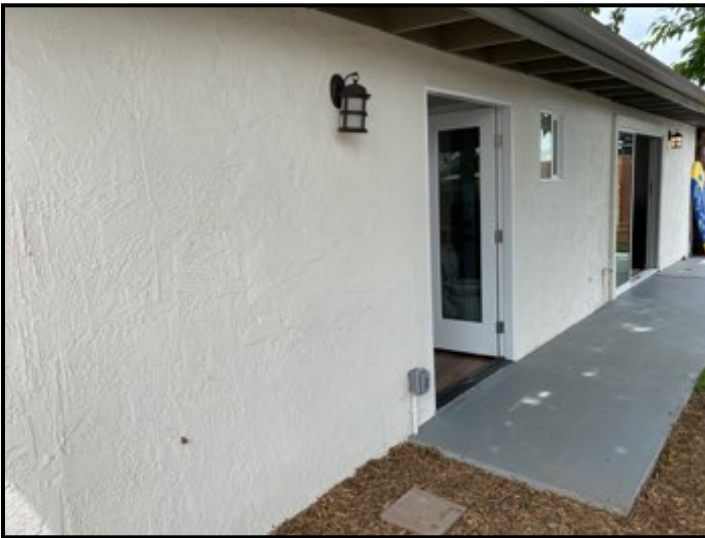
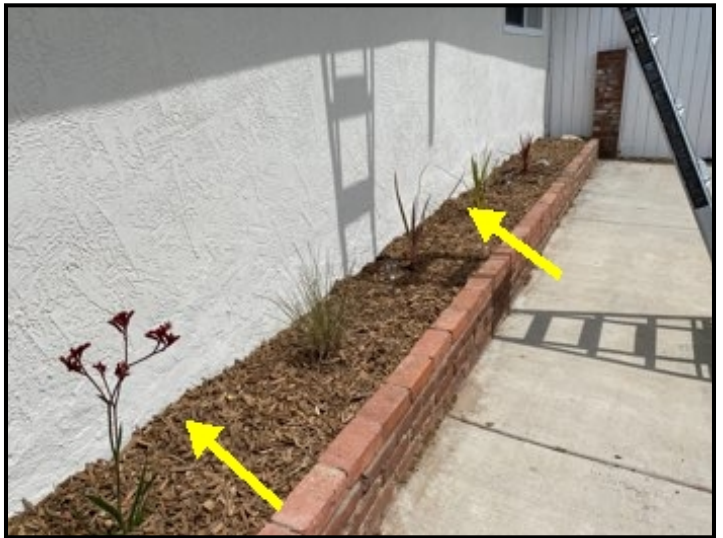
2.2. We recommend removing or avoid water the planter box to avoid moisture related issues to the stucco and exterior/interior walls.

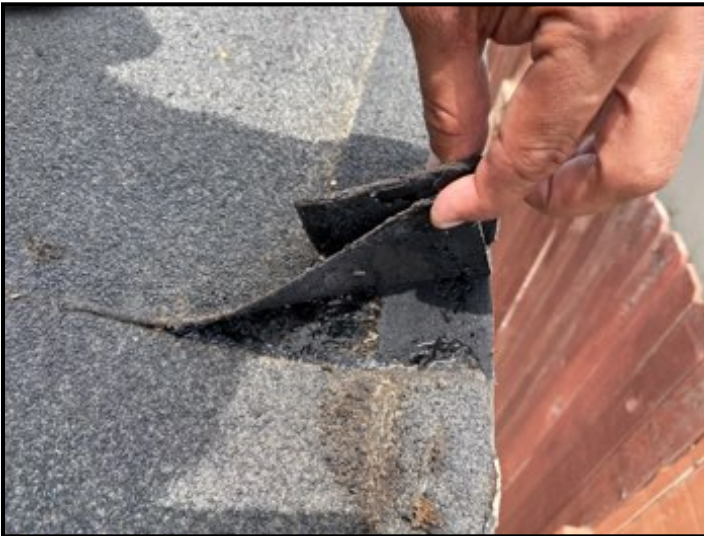
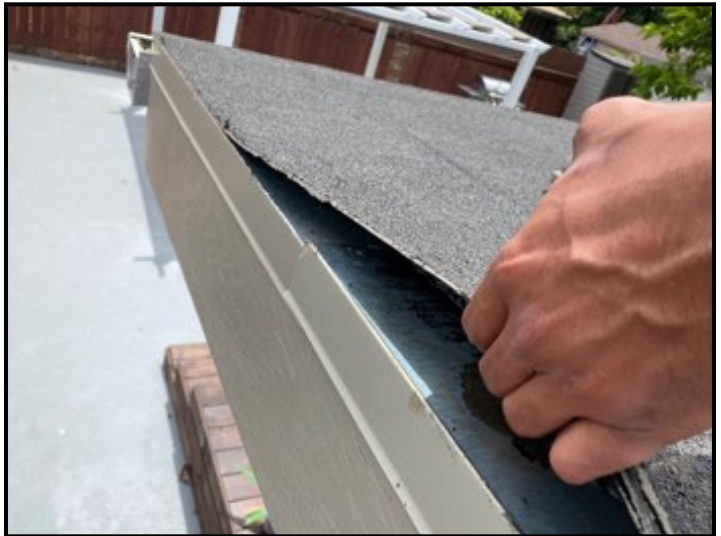
1.1. The rolled roofing material/cap sheet is not properly adhered to the roof and has lifting seams throughout the roof. Conditions are susceptible to moisture intrusion. Seek a qualified licensed roofing contractor for further evaluation and repairs or replacement.

1.2. The roof material appears to be a "peel and stick" roofing material and not a torch down material. Conditions may be susceptible to leaks and moisture intrusion. Seek a qualified licensed roofing contractor for repairs/replacement.

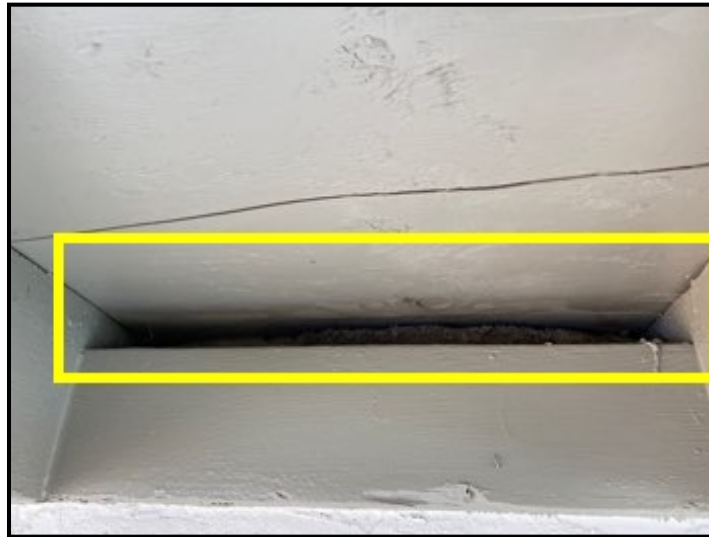
5.1. Vent screens are missing/damaged in some areas, suggest repairing or replacing screens as necessary.

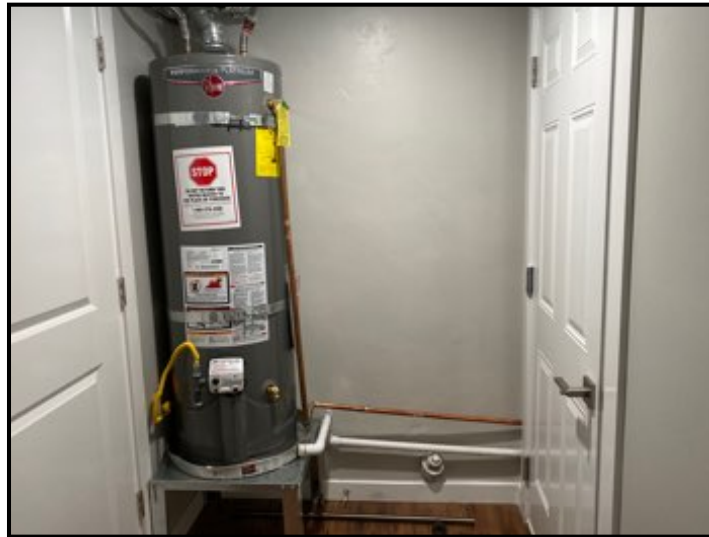
11.1. The water heater closet is missing ventilation ports top and bottom one third of the door to allow fresh **combustion air** to circulate inside the enclosure. Conditions may cause noxious byproducts to back draft and leak into the residence. Caution, potential safety hazard. Seek a qualified licensed contractor for further evaluations and repairs.

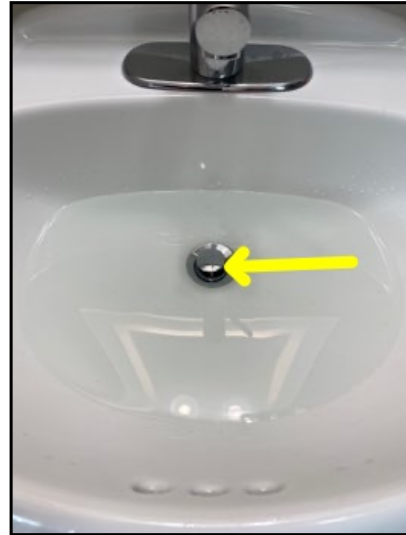
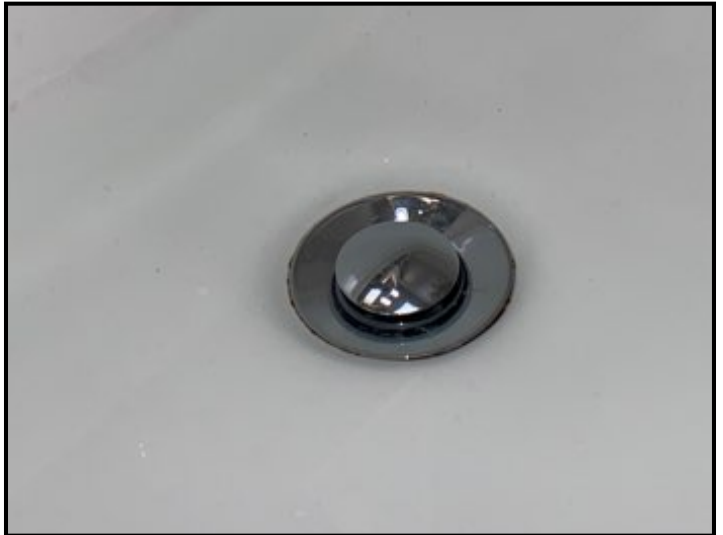
16.2. The master bathroom and guest bathroom sink appears to be clogged and does not drain. Seek a licensed plumbing contractor for repairs.
